UNDERWATER BRIDGE INSPECTION REPORT

STRUCTURE NO. 84524
CSAH NO. 32
OVER THE
BUFFALO RIVER
DISTRICT 4 - WILKIN COUNTY

PREPARED FOR THE
MINNESOTA DEPARTMENT OF TRANSPORTATION
BY
COLLINS ENGINEERS, INC.
JOB NO. 5221

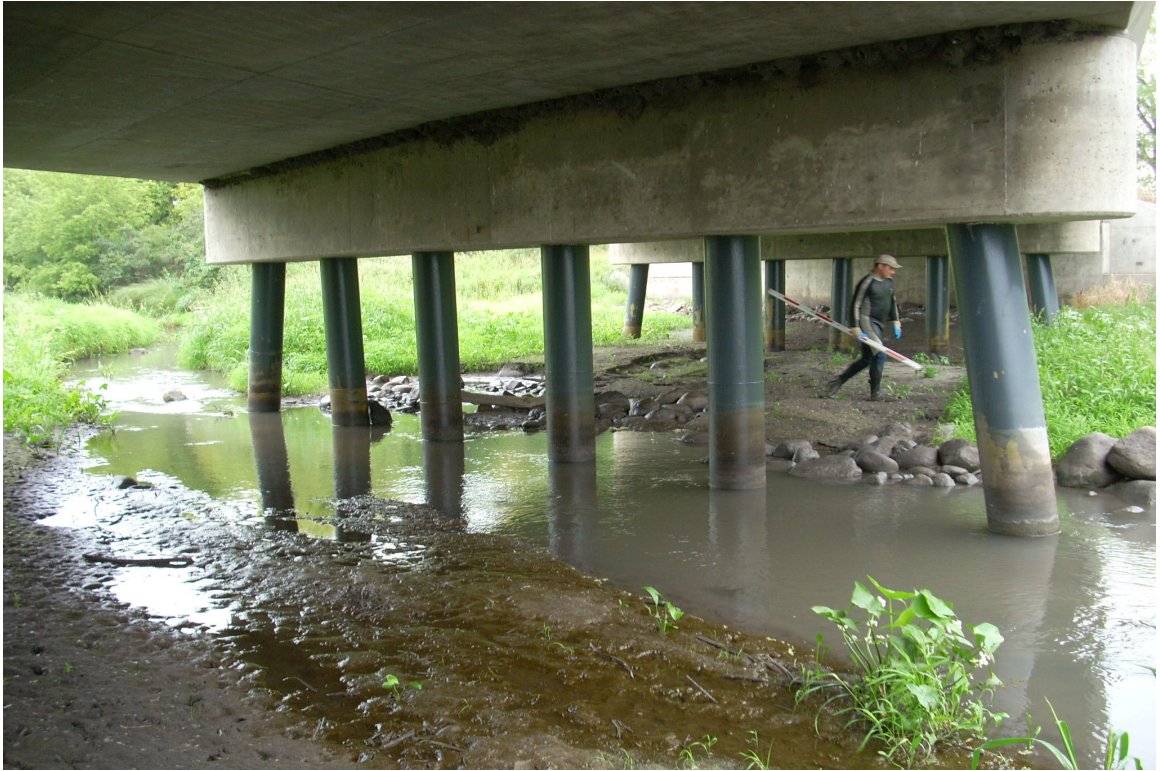
- (A) Piers 1 and 2 exhibited coating loss from the channel bottom to 3 feet above the channel bottom. The exposed steel exhibited minor surface corrosion with no appreciable loss of section.
- (B) A 10 foot long by 5 foot wide by 1 foot deep scour depression was observed around the two upstream piles of Pier 2.

Photograph 3. View of Pier 1, Looking Northeast.

- (A) Reinspect the submerged substructure units at the normal maximum recommended (NBIS) interval of five (5) years.

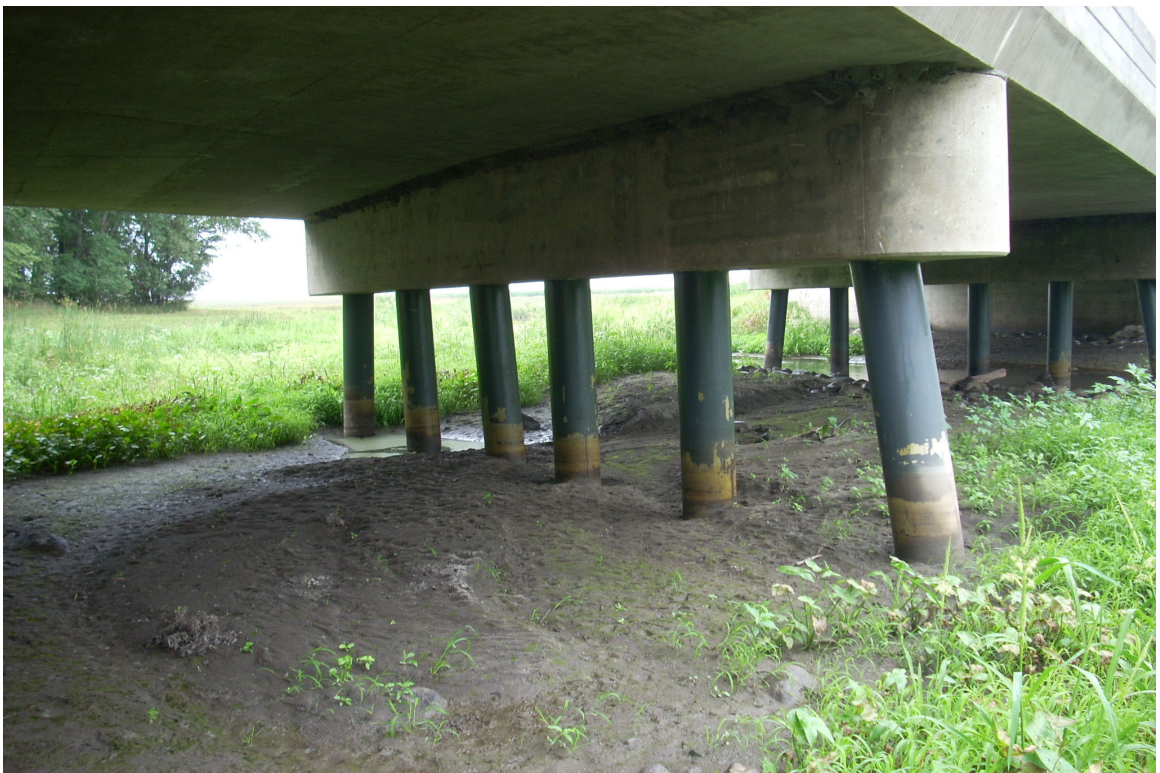
Photograph 4. View of Pier 2, Looking Southwest.

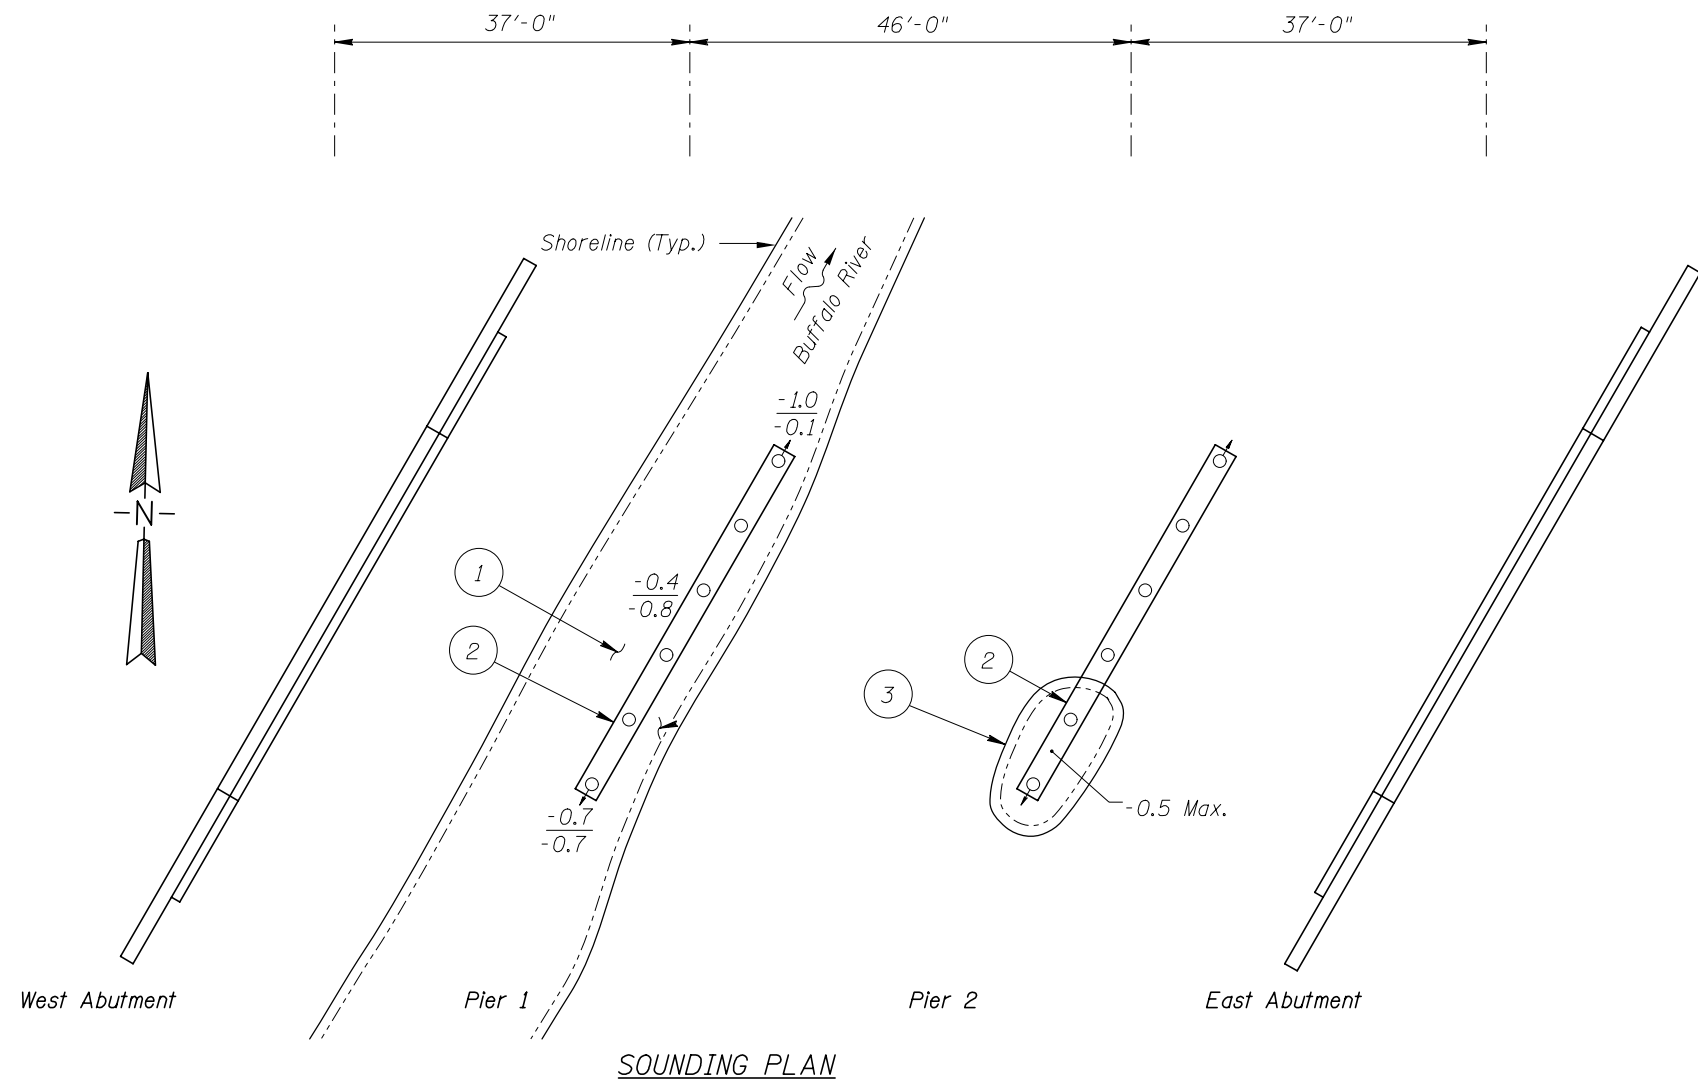
INSPECTION AND SOUNDING PLAN

- The channel bottom around both piers consisted of soft silt, sand, and random stones with up to 18 inch diameter with up to 2 feet of probe rod penetration.
- Piers 1 and 2 exhibited coating loss from channel bottom to 3 feet above the channel bottom. The exposed steel exhibited minor surface corrosion with no appreciable loss of section.
- A 10 feet long (N/S) by 5 feet wide (E/W) by 1 foot deep scour depression was observed around the two upstream piles of Pier 2.
